MAJOR ORIENTATION-ERROR ACCIDENTS IN
REGULAR ARMY UH-1 AIRCRAFT DURING
FISCAL YEAR 1970: ACCIDENT FACTORS

W. Carroll Hixson, et al

Naval Aerospace Medical Research
Laboratory

5 June 1974

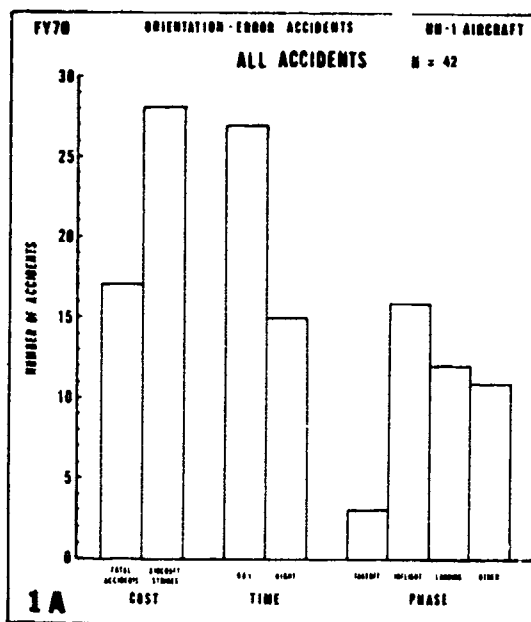
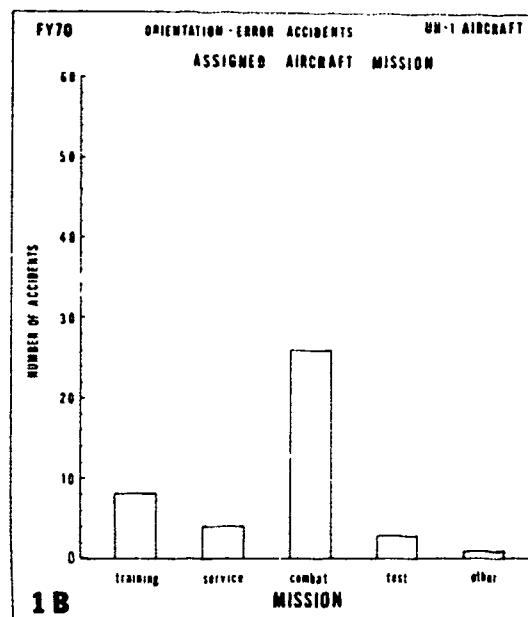
Major orientation-error accidents occurring in Regular Army UH-1 aircraft during fiscal year 1970. Number of fatal accidents, number of aircraft strikes, time of day of the accidents, and the flight phase in which the accident occurred (A); and types of missions assigned to the accident aircraft (B).

The layout and format of related data to be presented in this report follow those utilized in previous reports (refs. 3,6,9) of this series. Figure 1 summarizes the incidence of fatal accidents, aircraft strikes, day accidents, and night accidents; incidence according to flight phase; and incidence according to assigned mission. In Figure 2A a distribution is given of the number of accidents that occurred during each month of the fiscal year. The incidence of these accidents on a local-time basis is described by the distribution shown in Figure 2B. Comparative cost and flight phase data for accidents that occurred under daylight and night visibility conditions are presented in Figures 3A and 3B, respectively. The relative cost of night accidents continues to exceed that of day accidents. Similar data are presented for accidents involving degraded visibility due to weather and dust in Figures 4A and 4B, respectively. Weather was involved in 17 (40.5 percent) of the orientation-error accidents. The cost of weather accidents remains high in that 64.7 percent were fatal and 88.2 percent resulted in strike damage. Of the nine weather accidents that occurred in daylight, six accidents were fatal. Of the eight night accidents, five were fatal. The total of only three dust accidents is a considerable reduction from the incidence noted in previous years of the study.

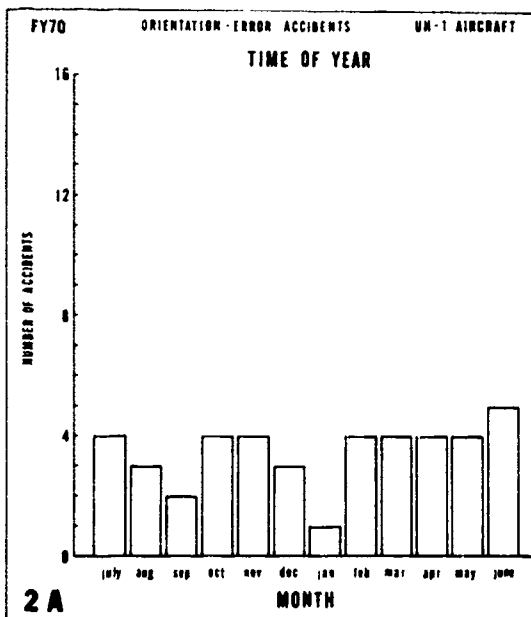
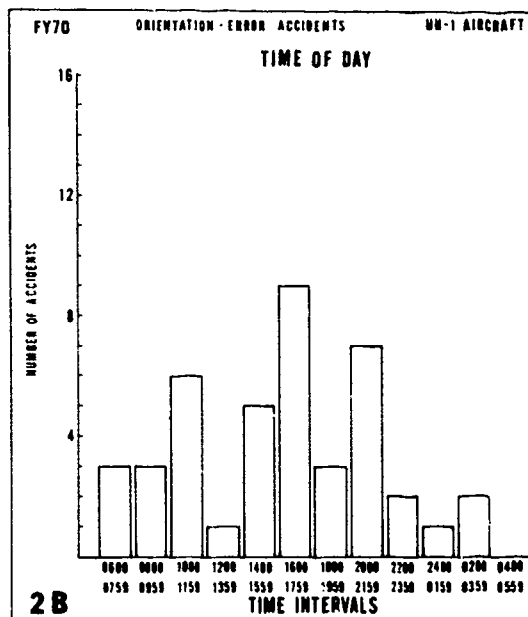
Figure 2

Number of orientation-error accidents as a function of the time of year (A) and the local time of day (B).

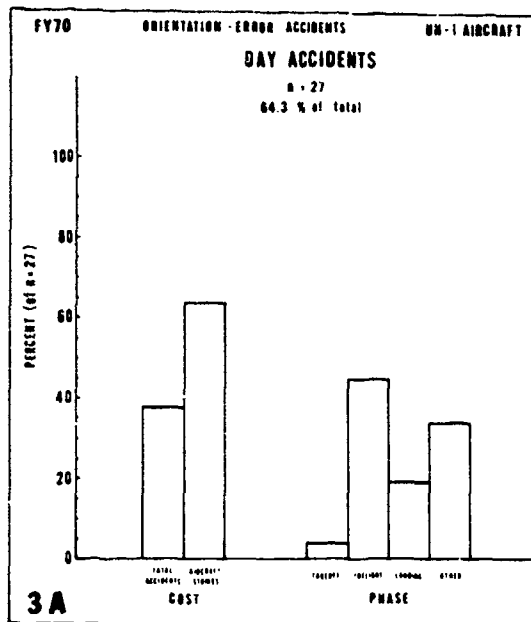
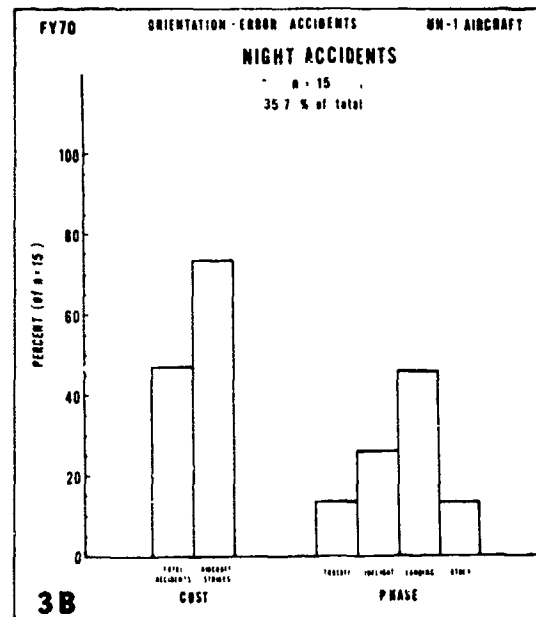
Figure 3

Comparison of percent incidence of fatal accidents, aircraft strikes, and flight phases for the 27 orientation-error accidents that occurred under daylight visibility conditions (A) and the 15 accidents that occurred under night visibility conditions (B).

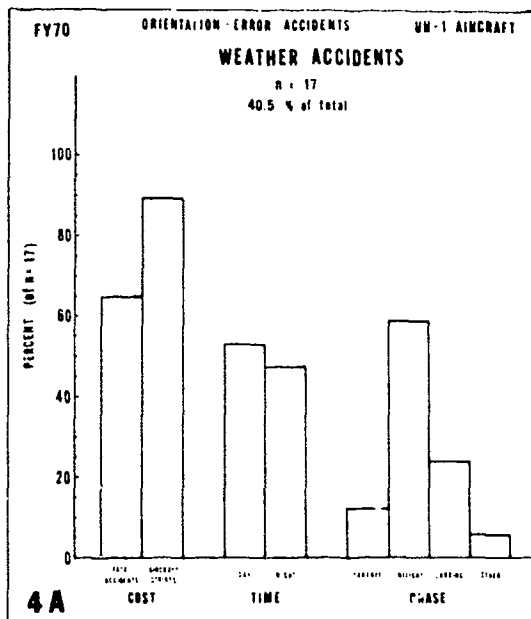
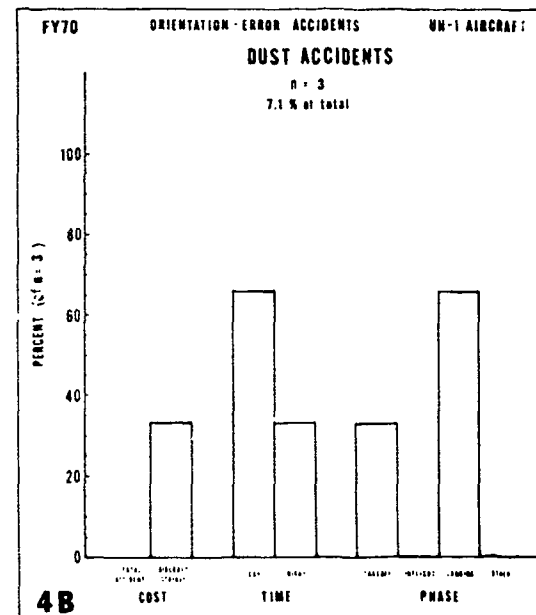
Figure 4

Comparison of percent incidence of fatal accidents, aircraft strikes, day/night accidents, and phases of flight for the 17 orientation-error accidents that involved poor weather (A), and the 3 accidents that involved rotor-raised ground dust or ashes (B). Note the high incidence of fatal accidents and aircraft strikes involved in the weather accidents.

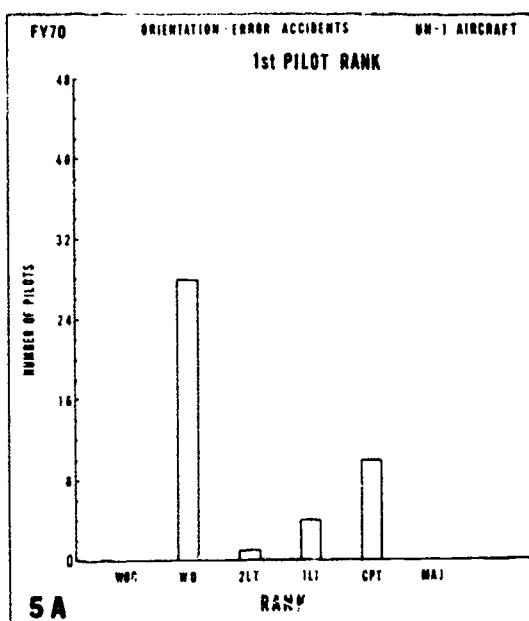
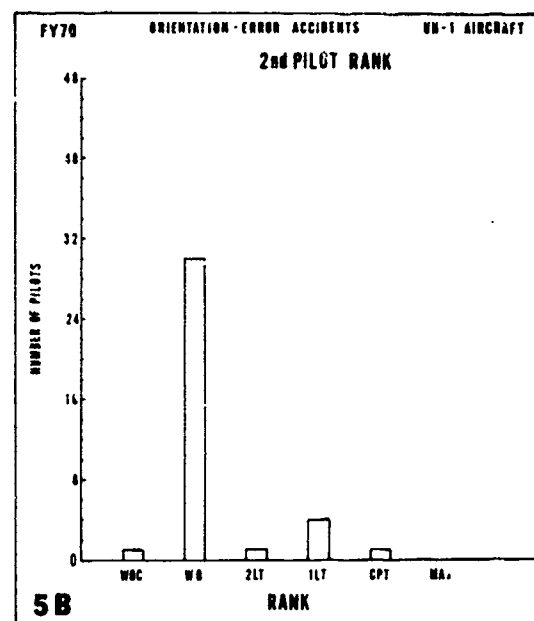
Figure 5

Distribution by rank of 41 first pilots (A) and 38 second pilots (B) involved in the orientation-error accidents. As explained in the text, the first pilot notation is used to describe the commanding aviator aboard the aircraft. In general, for Vietnam accidents, the first pilot is the "air commander" and the second pilot is the "pilot." For accidents occurring elsewhere, the first and second pilot notation usually corresponds to the conventional "pilot" and "copilot" designations, respectively.

In Figures 5 through 9, summary listings are made of various aviator-related background information. For each figure, a separate compilation is made for each of the two Army pilots normally aboard the UH-1 aircraft. The terms "first pilot" and "second pilot" have been arbitrarily selected to identify the commanding aviator (not necessarily the senior-ranked aviator) and his copilot, respectively. Outside of Vietnam, the first and second pilot notation corresponds to the conventional pilot (P) and copilot (CP) identification. In Vietnam, however, the two aviators are usually identified as the air commander (AC) and pilot (P); the air commander rating applies only after an aviator gains a certain minimum of in-country experience within the air unit to which he is assigned. An air commander is thus identified as the first pilot and the pilot as the

Data pertaining to the military rank of the first and second pilots are shown in Figures 5A and 5B, respectively. Age distribution data for the pilots are listed in Figure 6. Aviator experience in terms of total flight hours both in all types of military rotary wing (RW) aircraft and in the UH-1 aircraft is described in Figures 7 and 8, respectively. The median for the total recorded RW experience was 900 hours for the first pilots and 460 hours for the second pilots. In terms of UH-1 flight experience, the median time was 550 hours for the first pilots and 212 hours for the second pilots. Workload data concerned with the total number of hours flown by the aviators the 30 days preceding the accident are shown in Figure 9. The median times were approximately 82 hours for the first pilots and 71 hours for the second pilots. Army regulations place 140 hours per 30-day interval as the official upper limit relative to pilot fatigue. After 90 hours, however, observation of the pilot by the air unit commander and flight surgeon is required.

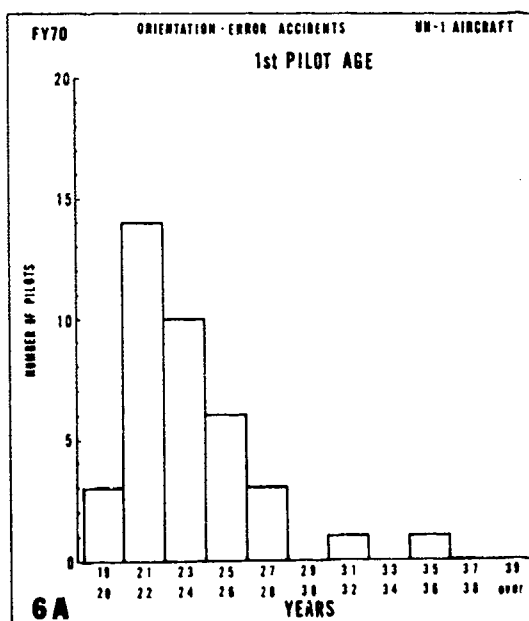
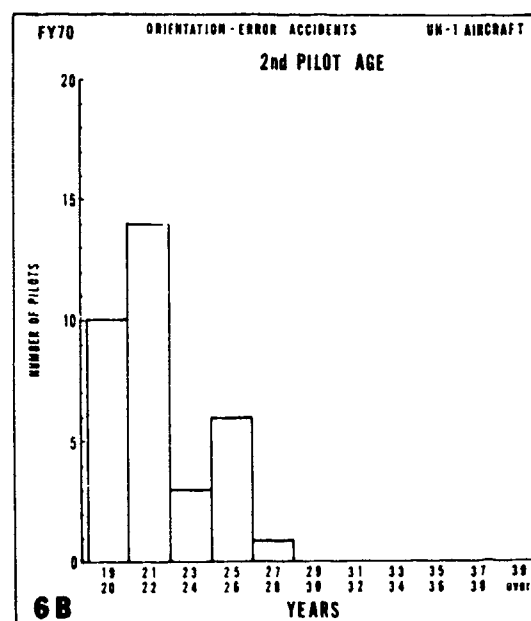
Figure 6

Age distribution of the first pilots (A) and second pilots (B). The median ages were approximately 23.4 and 22.0 years, respectively.

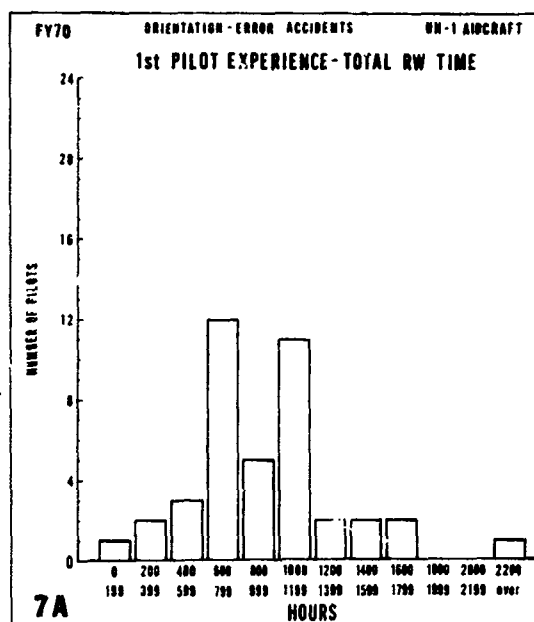
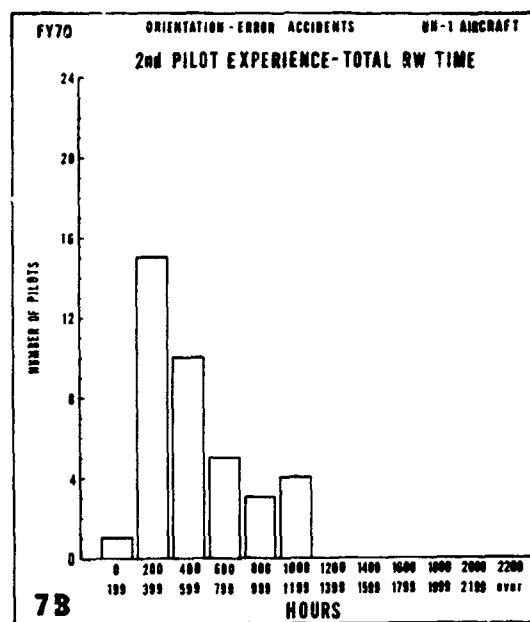
Figure 7

Distribution of total flight hours experience in military rotary-wing aircraft of the first pilots (A) and second pilots (B). The medians were approximately 900 and 460 hours, respectively. These data do not include any additional fixed-wing experience.

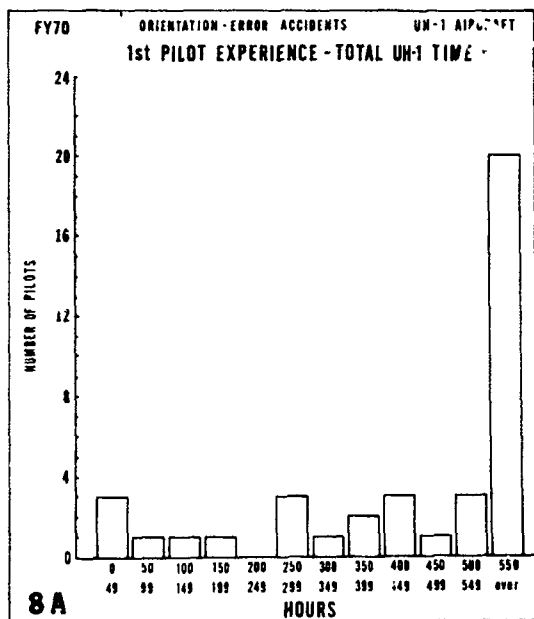
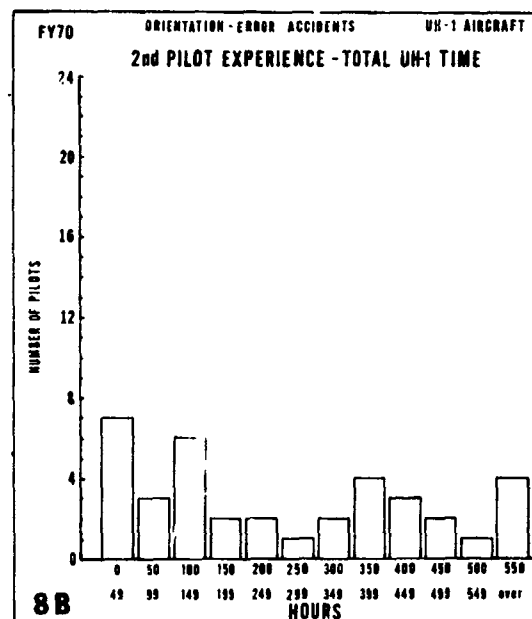
Figure 8

Distribution of total flight hours in the UH-1 aircraft of the first pilots (A) and second pilots (B). The median times were approximately 550 and 212 hours, respectively.

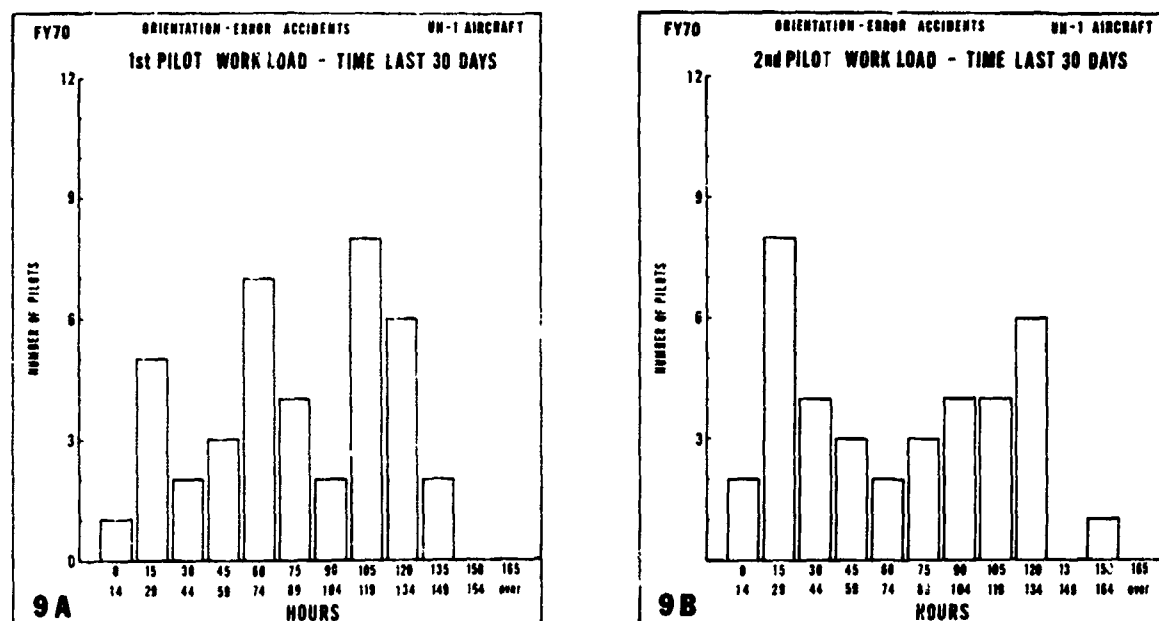
Figure 9

Distribution of pilot workload in terms of the total number of hours flown during the 30 days preceding the accident by the first pilot (A) and the second pilot (B). The median workloads were 82 and 71 hours, respectively. (See Figure 11 for related fatigue data.)

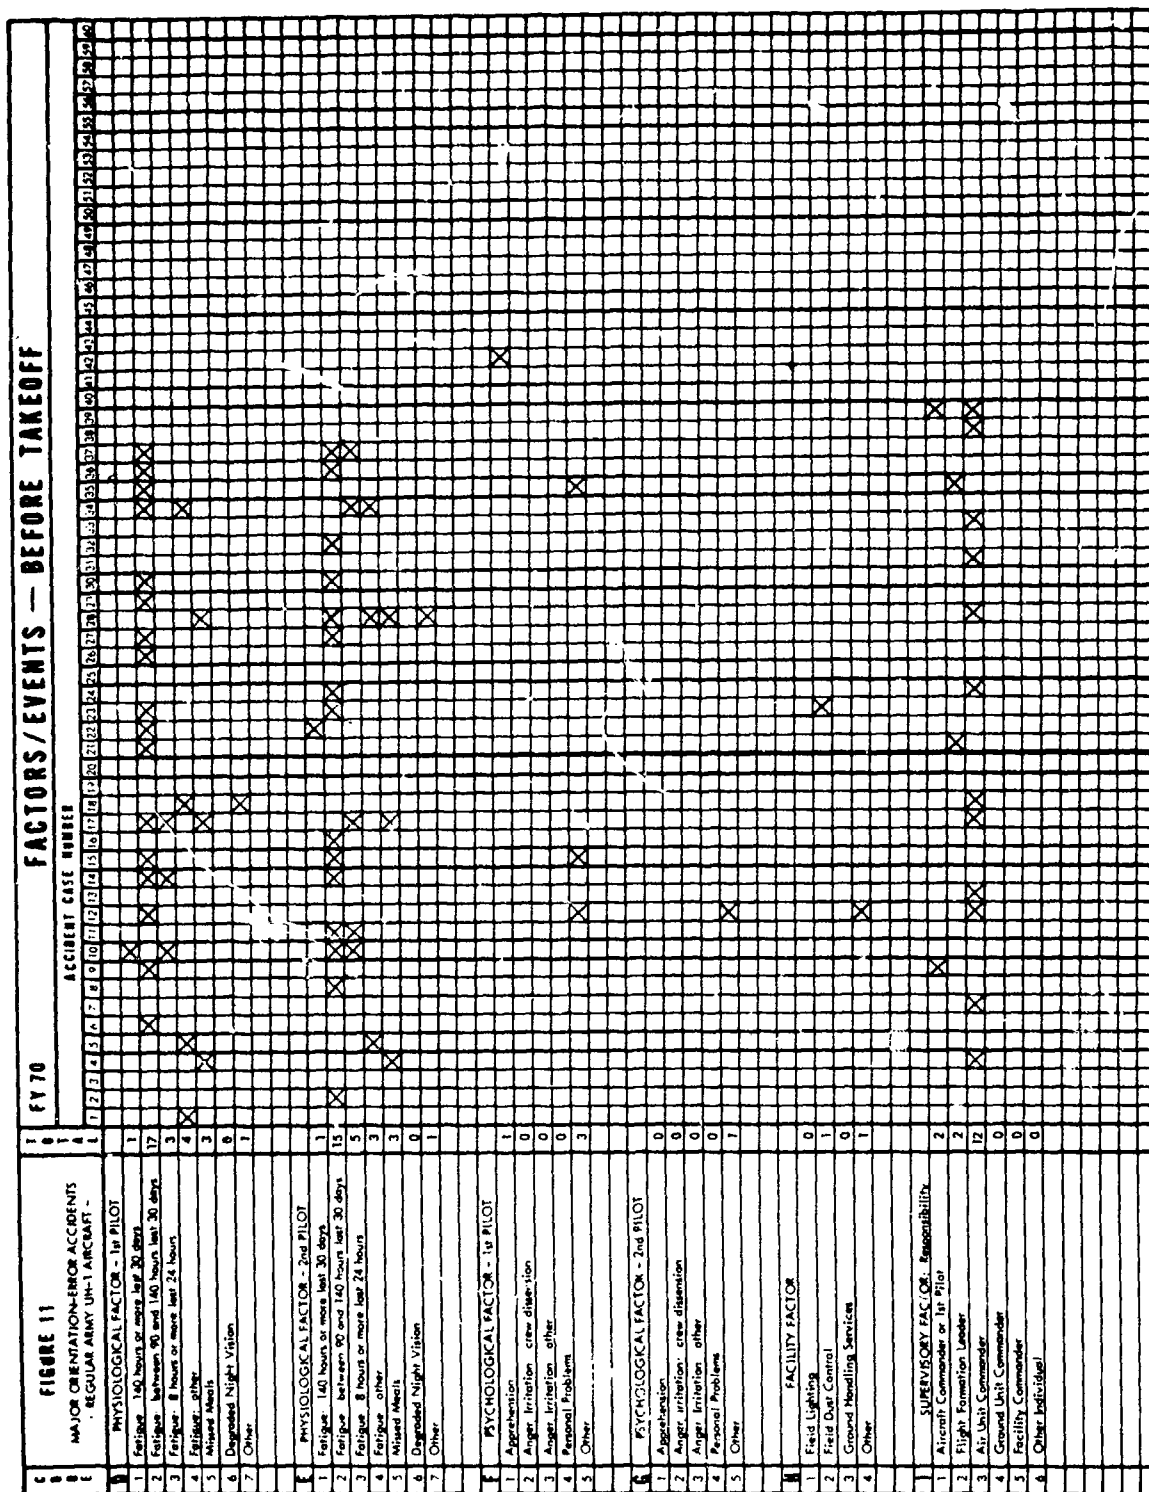
Figure 11

Individual case history listing of selected accident factors and events present before, or at the instant of, takeoff on the accident flight. See text for details.

The factor and event data presented in Figures 11 through 14 follow the Figure 10 format with the row entries continuing to be identified in alphanumeric sequence. It should be observed that Figures 11 and 12 are concerned with factors and events which were listed as being present, or having happened, in the time period preceding takeoff; Figures 13 and 14 list factors and events which occurred, so far as the crew were concerned, only after the aircraft became airborne. This approach has been selected with the long-term objective of possibly distinguishing between accidents that may occur as a result of initial conditions existing before flight, and accidents that may occur seemingly as a result of only some inflight event or factor.

In Figures 11 and 12, factors and events which were present before takeoff are listed under physiological, psychological, facility, supervisory, materiel, mission pressure, pilot preflight, and miscellaneous factor headings. The D and F headings pertain to physiological and psychological factors, respectively, associated with the first pilot while the E and G headings list the same factors for the second pilot. This separate listing allows a heavier weighting to be given these factors when both pilots, rather than only one, experience the related difficulties.

Relative to physiological problems that existed prior to takeoff, fatigue was found to be the most obvious factor. Four entries, D1-D4 for the first pilot and E1-E4 for the second pilot have been allotted to the description of this problem. Entries D1 and E1 denote aviators with greater than 140 total flight hours during the 30 days preceding the accident. Army regulations for Vietnam flight operations set this figure as the upper limit which cannot be exceeded except during tactical emergencies. Although it is possible to obtain permission at the battalion level to exceed this limit, the regulations direct the commanders to use the utmost discretion when granting this waiver. For fiscal year 1970 there were two accidents in which at least one pilot had flown more than 140 flight hours the preceding 30 days. The same Army regulations also state that a crew member who accumulates 90 hours in a 30-day period will be closely monitored by the unit commander and the flight surgeon. This monitoring requirement is thus an implied recognition of individual susceptibility to fatigue. For this reason, the authors have chosen to also identify those accidents involving aviators with a workload greater than 90 hours, and less than 140 hours during the preceding 30 days. The related D1-D2 and E1-E2 fatigue entries indicate 18 first pilots and 16 second pilots experienced this workload. There were 25 (59.5 percent) accidents in which either one or both of the aviators had flown more than 90 hours during the 30-day period preceding the accident. Of this total, 9 (21.4 percent) accidents involved the case where both aviators had flown more than 90 hours during the preceding 30 days. A third fatigue classification, D3 and E3, involves the identification of aviators who had flown 8 hours or more the 24 hours preceding the accident. Three first pilots and 4 second pilots experienced this workload. In entries D4 and E4, miscellaneous fatigue factors mentioned by the accident board, for example, long duty hours or interrupted sleep, are listed. Treating the four fatigue entries as a group, there were 28 (66.7 percent) accidents in which at least one aviator was exposed to one or more of the stated fatigue listings.

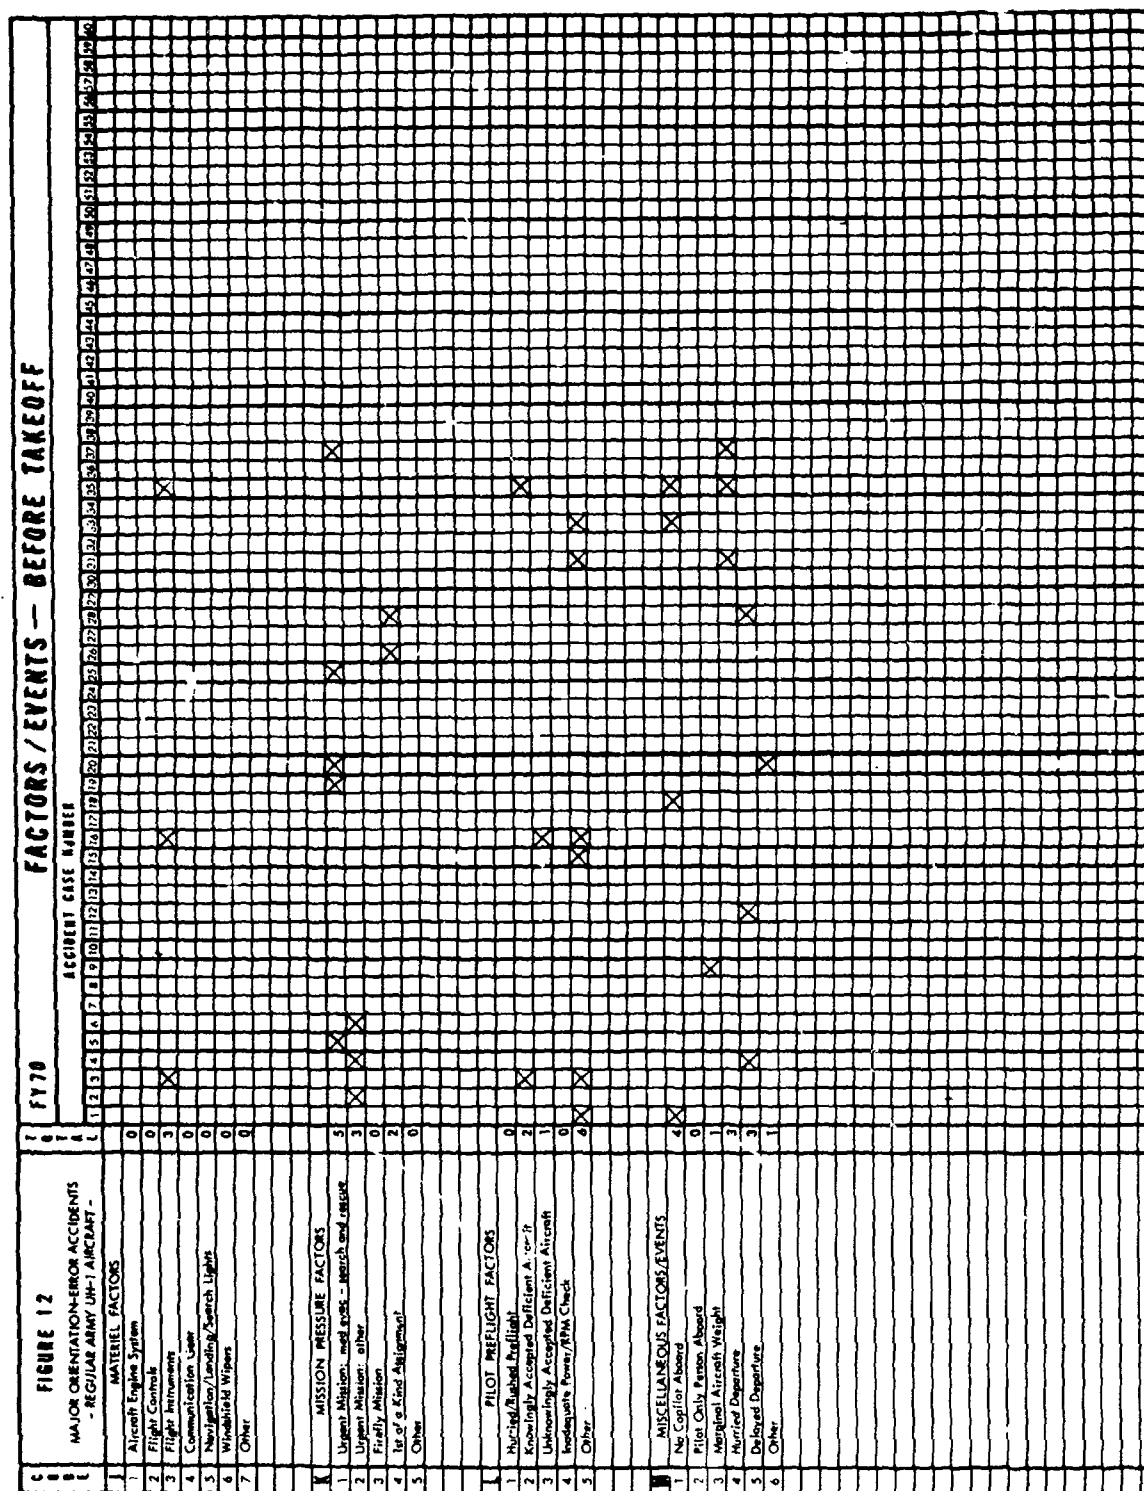
Figure 12

Continuation of the Figure 11 listing of before-takeoff factors and events.

Materiel deficiencies that existed before takeoff are listed under the J heading in Figure 12. The function here is to identify the accident situation where a materiel factor was known to be present, but not necessarily known to the aviators, before the aircraft became airborne. These factors are distinguished from the materiel failures that may have occurred while inflight and are listed under the R heading in Figure 13. It should be observed that an entry in one of the J listings does not imply that the materiel deficiency necessarily affected or effected the accident. The only implication is that there was some difficulty associated with the listed materiel item.
